AGENDA

ORDINARY COUNCIL MEETING

Tuesday 12 December 2023

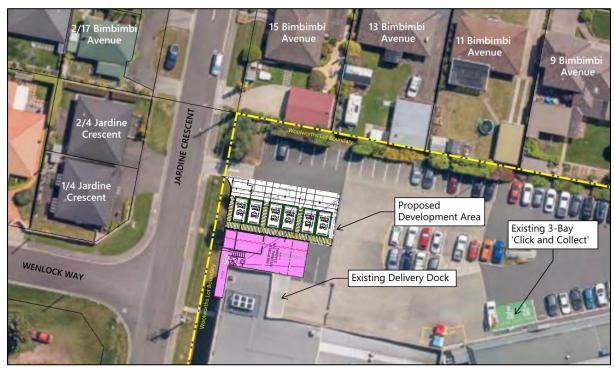
Figure 6: Aerial image showing the location of the proposed development area transposed along with features of this area of the site and adjoining and adjacent land.

The proposed works include construction of an addition on the northern side of the existing delivery dock area. The addition will include an enclosed building that will connect to the delivery dock. A car park canopy will extend from the northern side of the proposed enclosed building which will allow cars to park undercover to collect groceries (refer to Figure 6).

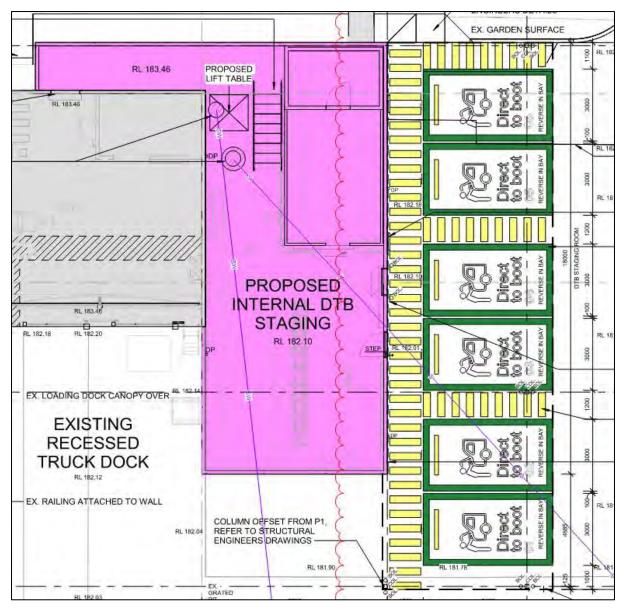
Figure 7: Excerpt of the Proposed Floor Plan showing the configuration of the proposed internal staging area and car park canopy.

The enclosed building will include a narrow section along the western side of the delivery dock (Jardine Crescent side) which will provide internal access around the delivery dock to the main area of the building, which is required due to a difference in finished floor level between the existing and proposed buildings. The enclosed building will function as a staging area for preparation and storage of orders and will have level access to the car park canopy. A goods lift and staircase will provide access between the existing building and proposed building where there is approximately 2m in level change. The canopy area will be painted green and includes branding and directional signage and lighting.

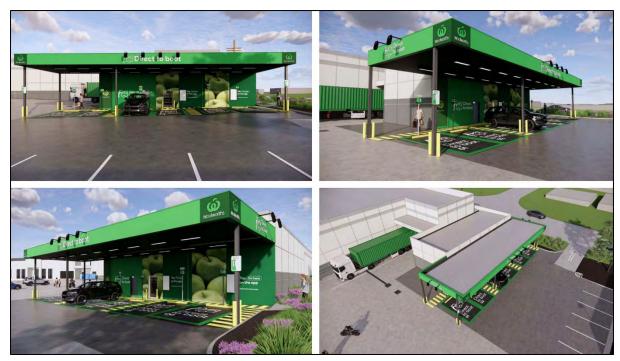
Figure 8: Excerpt of the Proposed Renders illustrating perspectives of the proposed development.

Visual perspectives of the proposed development are illustrated in Figure 8.

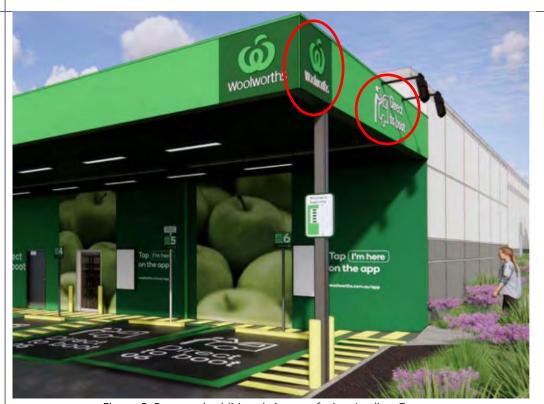
Figure 5: Proposed additional signage facing Jardine Crescent.

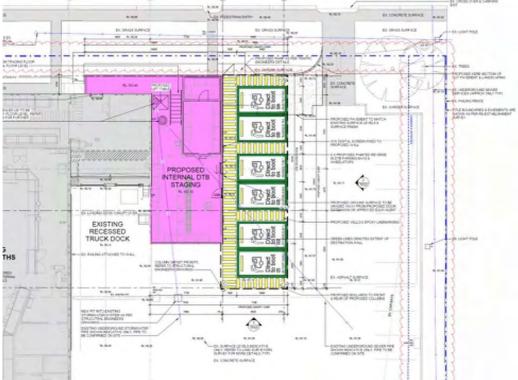
Figure 2-1 Proposed Pick up Layout

To accommodate this option, it is proposed to install pedestrian paths such that each bay is serviced by at least one (1) path. The entire Pick up area will be serviced by a main pedestrian path running east-west along the front of the Pick up bays to ensure Woolworths staff safety. The new footpaths will be utilised by Woolworths staff to safely access customer's vehicles from the Pick up store entrance.

All modifications adhere to Australian Standard 2890.1:2004 and are shown in Figure 2-1 and Appendix A.

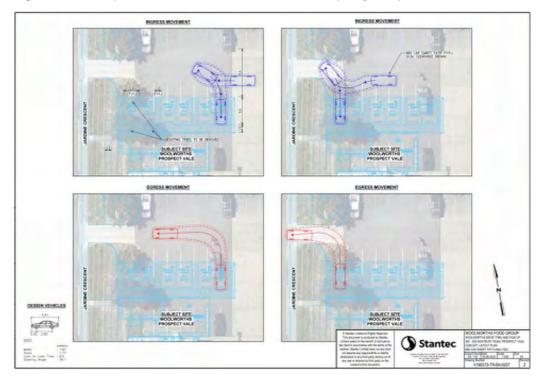
Figure 2-2 Proposed Reverse-In / Forward-Out Pick up Bay Swept Paths

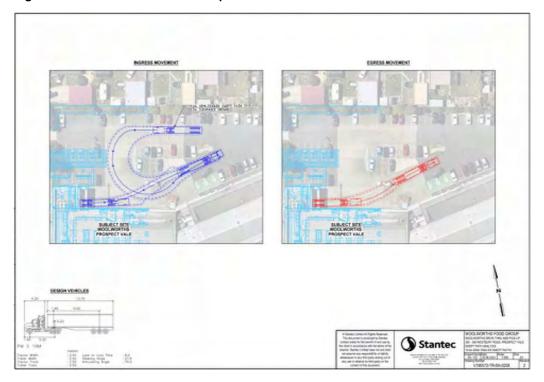
Figure 2-3 19m Semi-Trailer Swept Paths

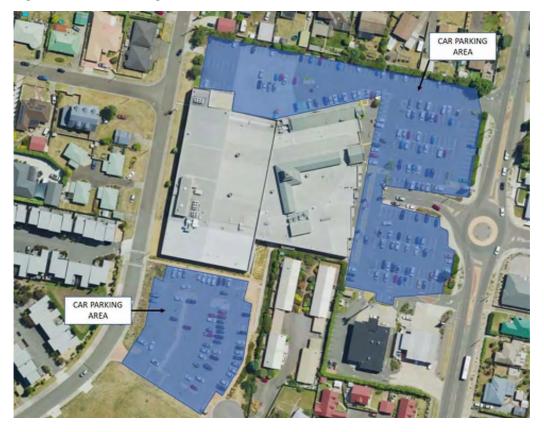
Figure 4-1 Car Parking Area

As the above shows, the average utilisation across the previous 10 aerials was shown to be 51%, with peak periods seeming to operate at a utilisation of approximately 65%. Introducing the Pick up parking spaces would therefore result in conservative utilisation increase of approximately 1%.

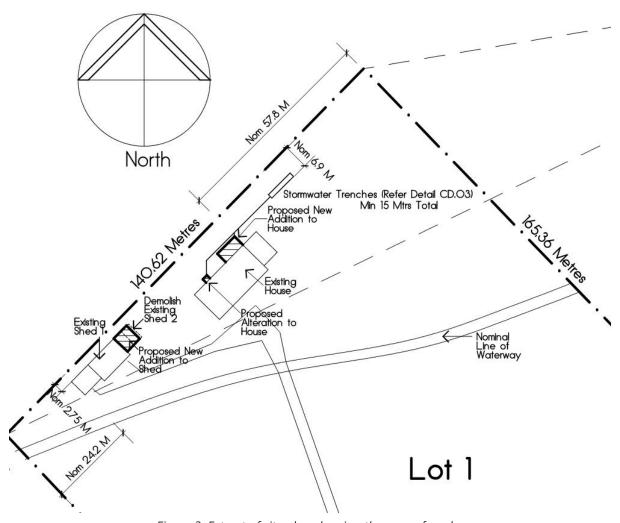
Figure 3: Extract of site plan showing the area of works.

The extension to the dwelling involves the removal of a small existing porch and the construction of a 3.6m \times 8.5m (floor area of 30.6m²) sunroom. Another existing porch area will be renovated as part of the works.

The extension to the garage will add a space, $6.7 \text{m} \times 6.35 \text{m}$ (floor area of 42.5m^2), apex height of 2.95 m, for a residential workshop and hobby room. To facilitate this, an existing garden shed will be demolished.

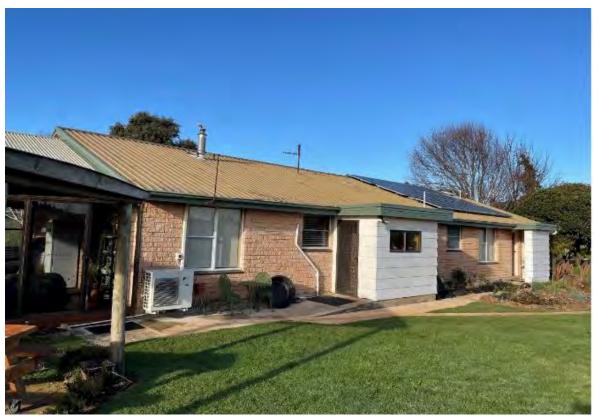
Figure 6: Northwest elevation of existing dwelling, location of new sunroom and porch.

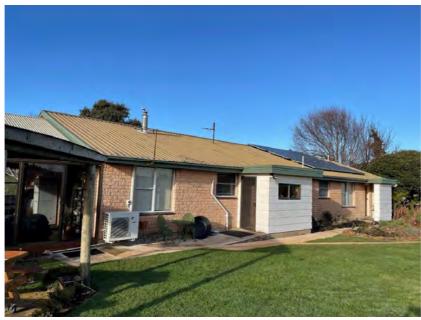
Rear of House – Sunroom addition to left after porch demolished; Small porch – roof and wall cladding replaced.

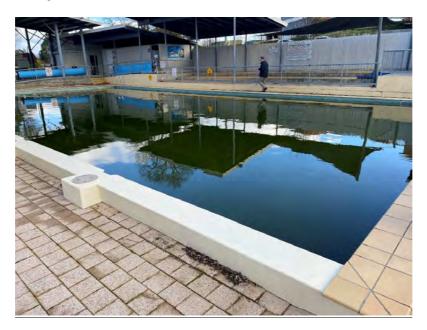
3.1 Deloraine Swimming Pool

The pool at Deloraine is a 25 yard (23m) outdoor swimming pool, of a 10 m width. It is 0.9 m deep at shallow end and 1.6 m deep at the deep end, and has a consistent grading along the length of the pool. Additionally, an outdoor toddlers pool has been constructed on the site is approximately 4 m long and 2.5 m wide. The pool is of varying depths, to a maximum of 400 mm. There is also a water feature channel on the western side of the pool consisting of a 600 mm wide and 150 mm deep spoon drain arrangement. The main pool is heated whereas the toddlers pool is not.

Key findings from the condition assessment at the Deloraine swimming pool:

• there was localised concrete pitting and chip damage to the gutter ledge in the south-eastern corner of the pool. Whilst visibility was poor due to the condition

- of the water (which would be expected in the off-season), it is likely that similar gutter damage would be present throughout the pool.
- Uncharacteristically there did not appear to be a central expansion or construction joint at the mid length of the pool

- from discussions with the pool operator, there did not appear to be any issues with the pools watertightness
- condition of the concrete shell is not considered to be structurally dangerous nor was there evidence that the shell is at risk of failure that would place patrons at risk or cause unscheduled closure of the facility

- the rubber paint coating generally has a life of 4 to 5 years and as such it
 appears that it is reaching its end of life. Prior to the commencement of any
 works it is recommended that the underlying render coating also be assessed
 for damage or failures in the applied render. At this time it would also be
 prudent to undertake repair to the perimeter gutter ledge to address the
 concrete damage

- it would appear that the tiles on the north, south and west sides of the pool are of a load group B/R9 slip rating, however pools generally require load group C/R 12 rating. It is recommended that Council undertake an internal risk assessment, which would include contacting the manufacturer to obtain a slip testing certification document.

- there was localised chip damage and the full debonding of one tile along the deep end/South end hole at mid point of the wall, likely caused due to the overhang

- the top side of the perimeter hop to the east side of the pool had been rendered and painted. Whilst there was no evidence of damage to the surface of the hob, the paint coating does not provide a compliant slip rating and is considered a slip risk

- whilst the climb out ladder appeared to be in a satisfactory condition, the general stair arrangement does not satisfy the relevant access codes and standards

A major recommendation is that the finishes applied to the pool be refurbished.

Administer localised patch works on a reactive basis to address what we would anticipate as being ongoing localised patch failures of existing applied tiling system across the perimeter hob of the 25 m pool. Such an approach would warrant the councils acceptance of the risk profile associated with such.

Fully remove all pool internal paint and render coating and top of hob tiling systems. Administer any necessary repairs to areas of the pool shell that have been subject to spall damage or where any existing crack damage warrants repair. Apply a new cementitious render to all internal surfaces of the pool and perimeter hob wall. This applied render system must be appropriately specified with consideration to suitably and adaptability to the applied paint coating and hob tiling systems. Following the completion of these works, consider one of the following two options:

A new stainless steel stair handrail that complies with relevant standards should be installed at the time of such works.
